## PROSIDING XXVII DAN KONGRES X PERHAPI 2018

### GROUND DEFORMATION MONITORING BY CONVERGENCE MEASUREMENT AND DAMAGED AREA MAPPING IN DEEP ORE ZONE (DOZ) MINE AT PT. FREEPORT INDONESIA

**ANDRE SEBASTIANO GINTING and HADNALTIAS ALPEKI** Underground  
Geotechnical and Hydrology Department, PT Freeport Indonesia, Tembagapura,  
Indonesia

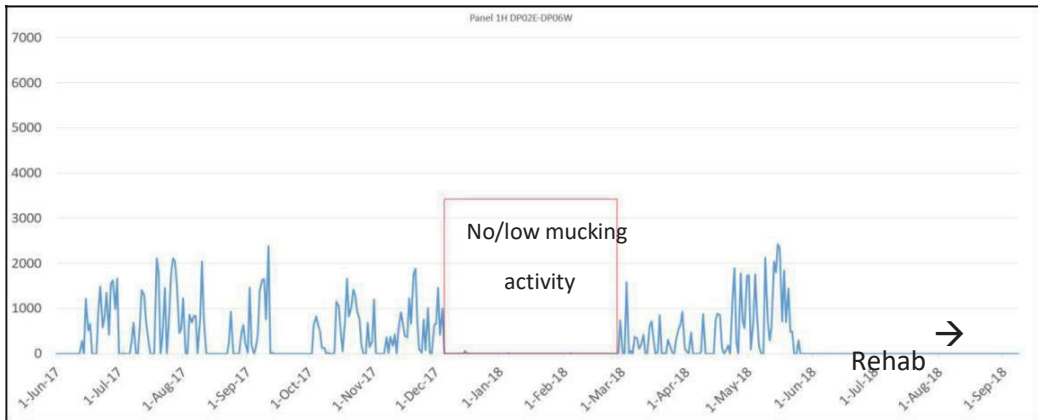
Pillar damage in Deep Ore Zone (DOZ) caused by no mucking activity, isolated drawpoint, dynamic load seismic event, and hit by loader. In this case, pillar damage

mostly caused static load which It has related to no mucking activity on the drawpoint. Based on mucking activity data and time of rehab, damage and significant displacement found after no mucking activity for long time, such as the graphs as below.

1. Ground always searches for stable condition when there is excavation. No mucking activity on a drawpoint will be static load/stress to the drawpoint. Uniform mucking activity is the better way to reducing potential damage occurred on pillar.
2. PT. Freeport Indonesia still keep safety as first value beasuce PTFI have responsibility for all the underground employee. “If there is no monitoring, then there is no mining”
